**CSAT 24 June 20**

# **COLD SPRAY IMPLEMENTATION AT RUAG**

# Additive Manufacture – Changing Nature of Sustainment

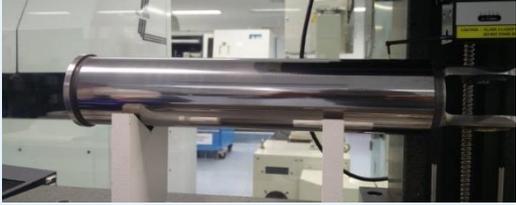
- 4 MLG Part Numbers and 7 NLG Part Numbers with SPD have been delivered
- Both MLG and NLG (with spin up have successfully passed Drop test )

Item Name	Dia/Lgth (Ins)	Material		
MLG Pin	1.49/5.65	SS

MLG Piston	2.74/ 12.5	SS

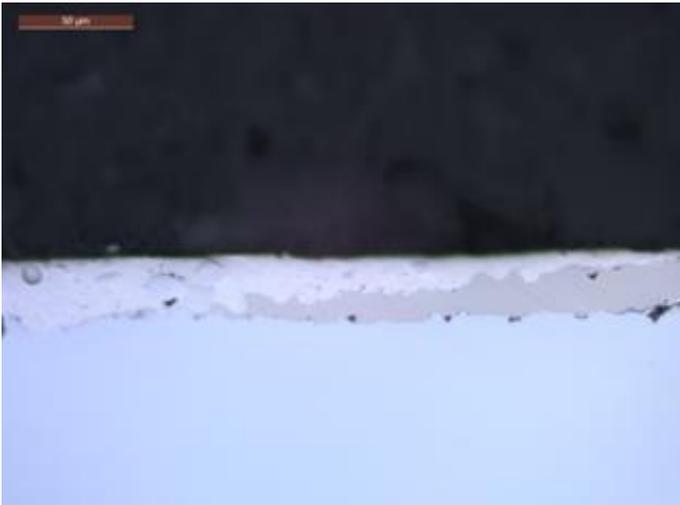
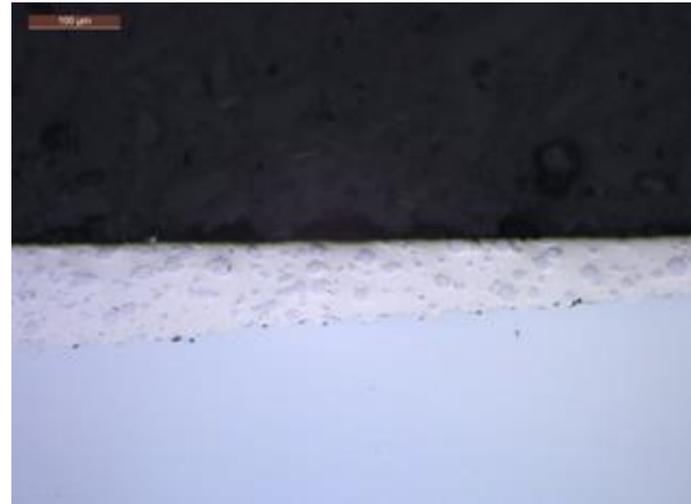
*Ni blend SPD coating at EN-Nickel and 4340 substrate transition area (a) and to 4340 (b) after grinding*

- The SPD NiCr-/CrC demonstrated acceptable wear resistance and hardness properties that were better than /equivalent to the existing EN coatings
- The SPD NiCr-/CrC demonstrated acceptable corrosion resistance properties performance with no indication that there were any “dissimilar metal” issues between the SPD and the EN coating.
- The SPD was compact with no observed porosity.
- The SPD was well adhered to the EN coating
- Trial repairs confirmed the hypothesised potential that SPD technology using an optimised SPD nickel blend powder could provide a viable and very effective solution for localised damaged/pitted EN coatings.

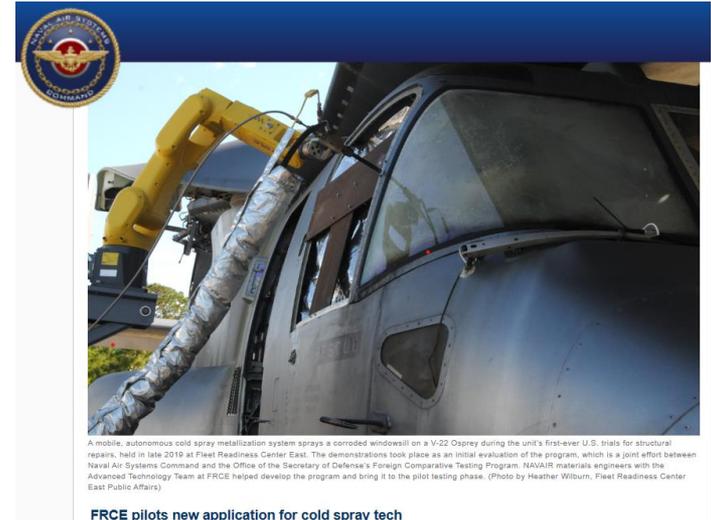
- May'19: Unit No 1 successfully trialed by USN with VRC Metal Systems support at Hawaii Oct '19:
- Oct 2019 - Completed trials @ USN Fleet Readiness Centre East (FRCE). Demonstrated to Boeing for V-22 airframe repairs as part of the trials. {USN Feedback – “The Brolga did great”. “OSD (program sponsor very pleased with the trials)”}
- Nov'19: Completed trials at the USN Fleet Readiness Centre Southeast (FRC-SE) in Jacksonville, FL. {USN feedback – “Demo went great. They want to keep the unit”}.

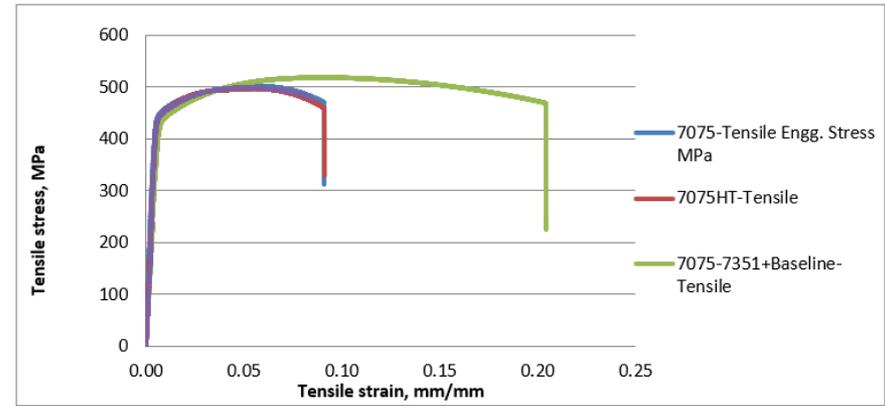
- Stress-strain curve of the laser treated SPD 7075 on 7075-T7351 substrate shows very similar results to the non-heat treated samples
- The coating was closely monitored during the test. It was seen that coating does not crack in the elastic period. Both the applied and heat treated coating he coating started to crack after the material passed the yield point, at approximately 2.82% elongation.

Figure 7: Average tensile stress/strain comparison to the as-sprayed and post-laser heat treated specimens

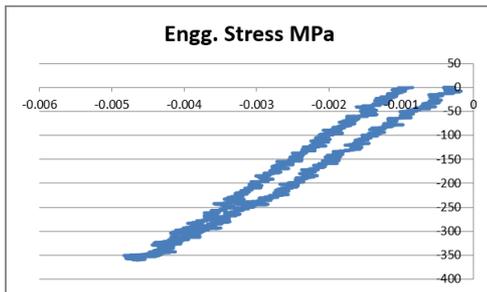
Figure 10b: Compression test curves of SPD 7075

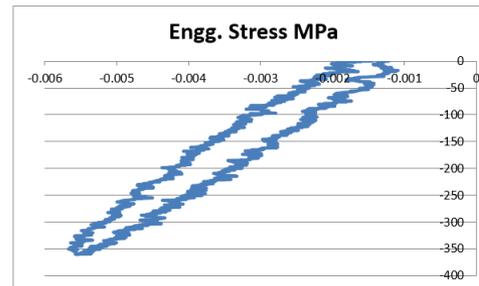
Figure 10c: Compression test curves of laser-treated coating

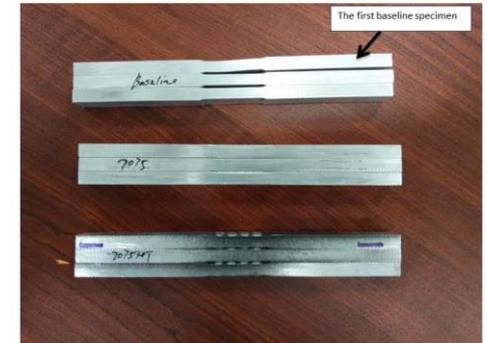
- All specimens (except first baseline specimen) retain integrity after compression test.
- No adverse effect of reduced hardness was evident.

Figure 8: All specimens (except first baseline specimen) retain integrity after compression test.

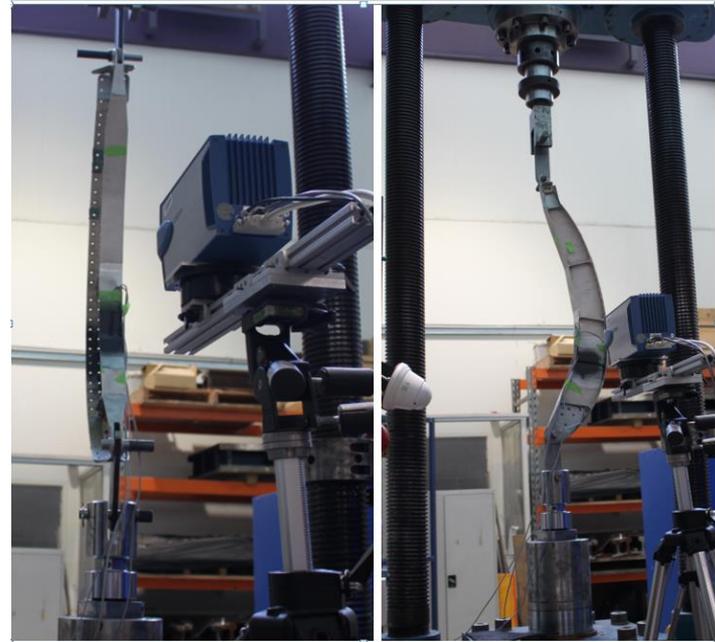
The resultant infrared thermography stress picture show approximately 16% reduction in the stress field at the critical location as a result of SPD Application.

Conduct fatigue life evaluation of SPD enhanced frame

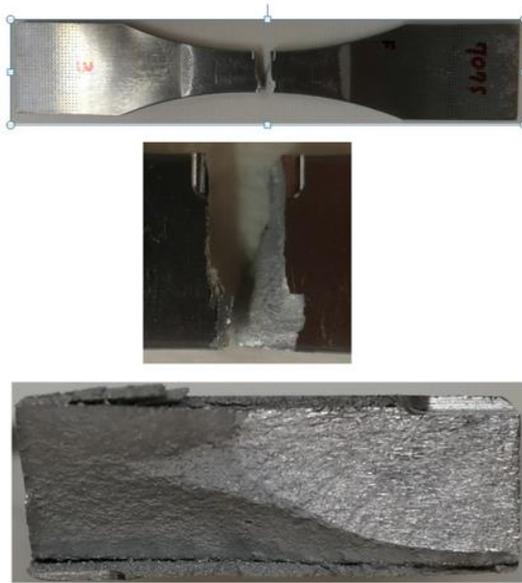
Figure 36 - Failure in the specimen with a 7075 SPD application tested at the block loading spectrum

For the 7075 SPD application under the cyclic fatigue loads spectrum, there is good agreement between the measured and predicted results.

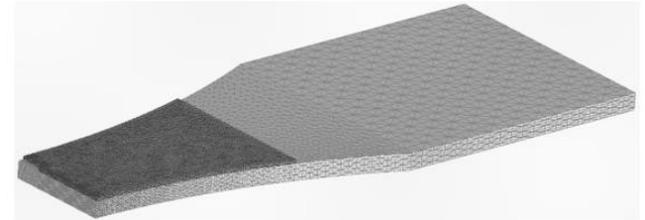
Figure 42 - Mesh used in fatigue analysis

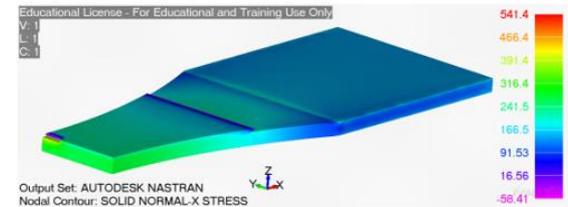
Figure 43- Resultant normal-x stress for the case of notch length = 5 mm at a remote load of 30 kN

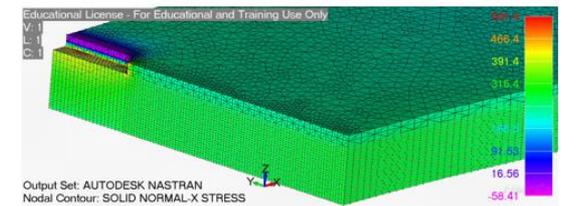
Figure 44 - Local detail analysis for the case of a 5 mm long notch in the SPD
